C&W Environmental Consulting, Inc.

July 1, 2011

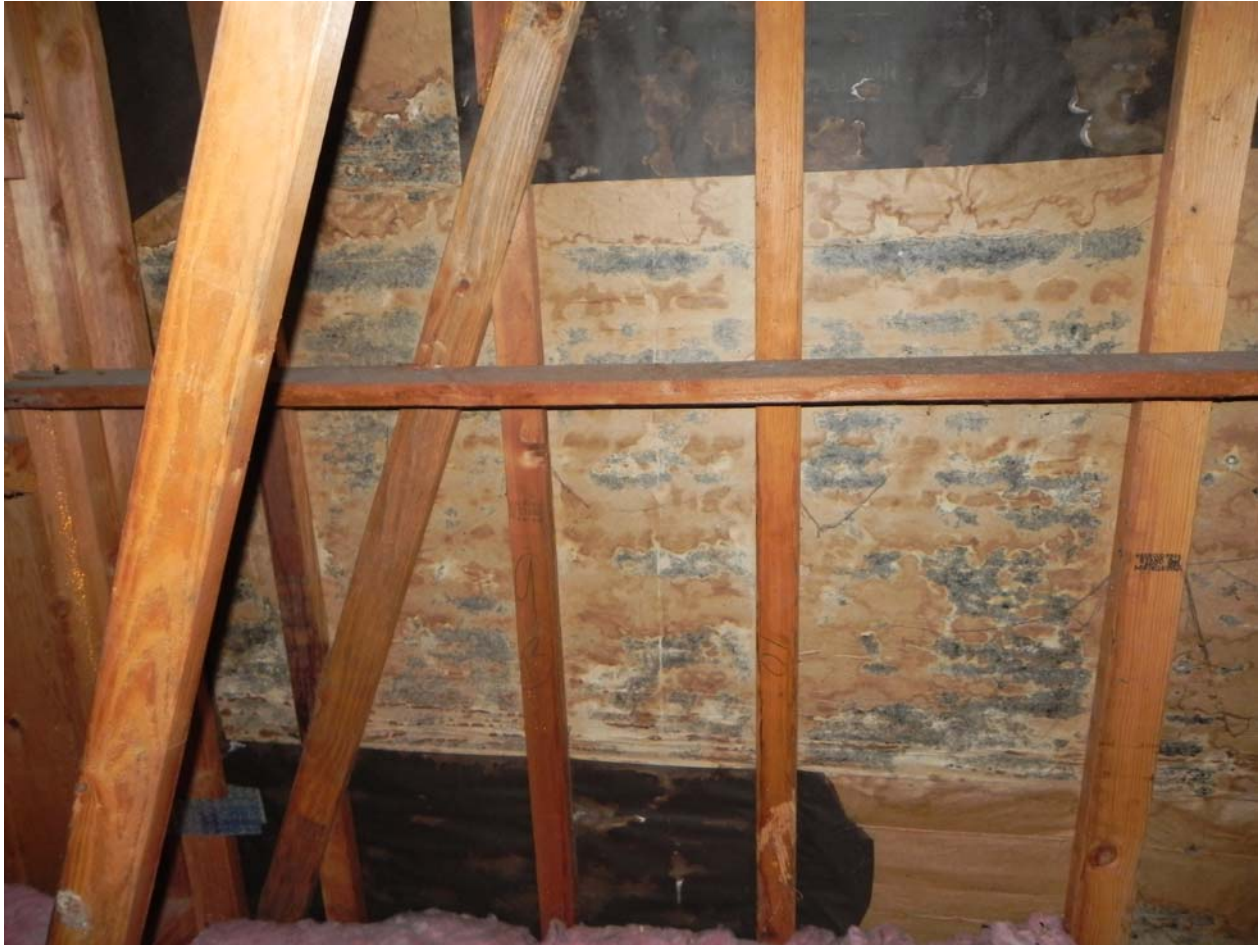
Attic Space – Gable at East End – Moisture Barrier Paper – Visible water and mold damage

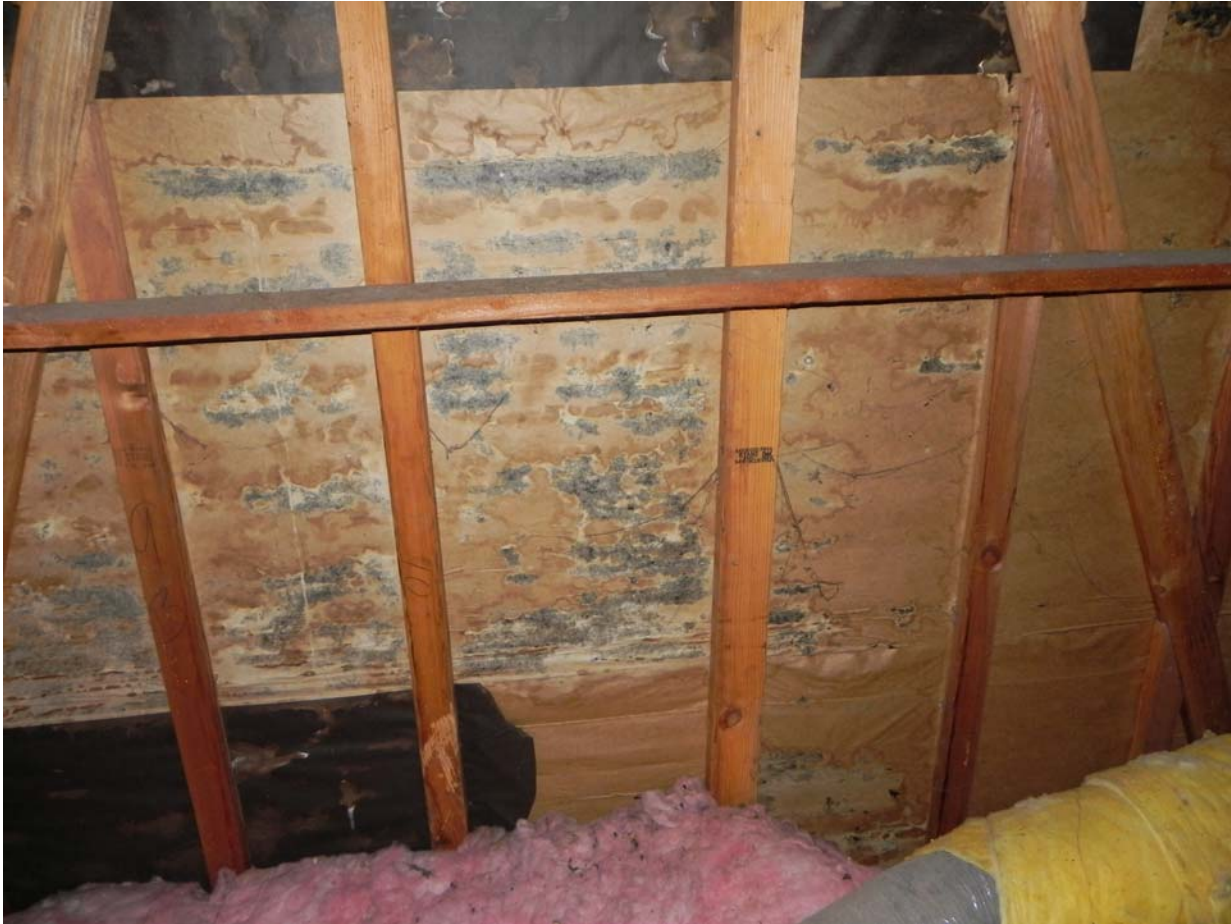
Attic Space – Gable at East End – Moisture Barrier Paper – Visible water and mold damage

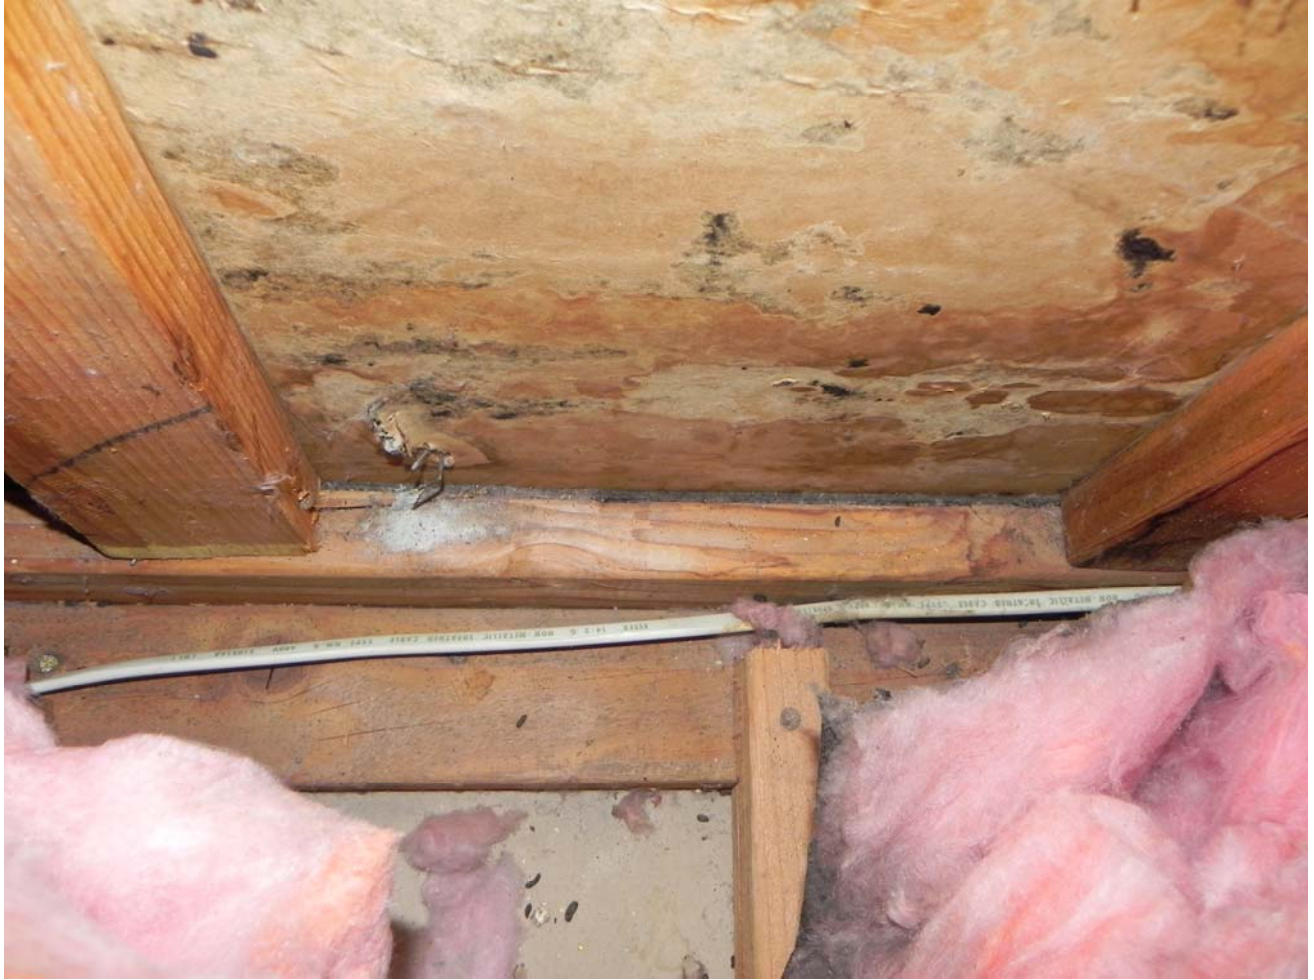
Attic Space – Gable at East End – Moisture Barrier Paper – Visible water and mold damage extending upward from attic floor

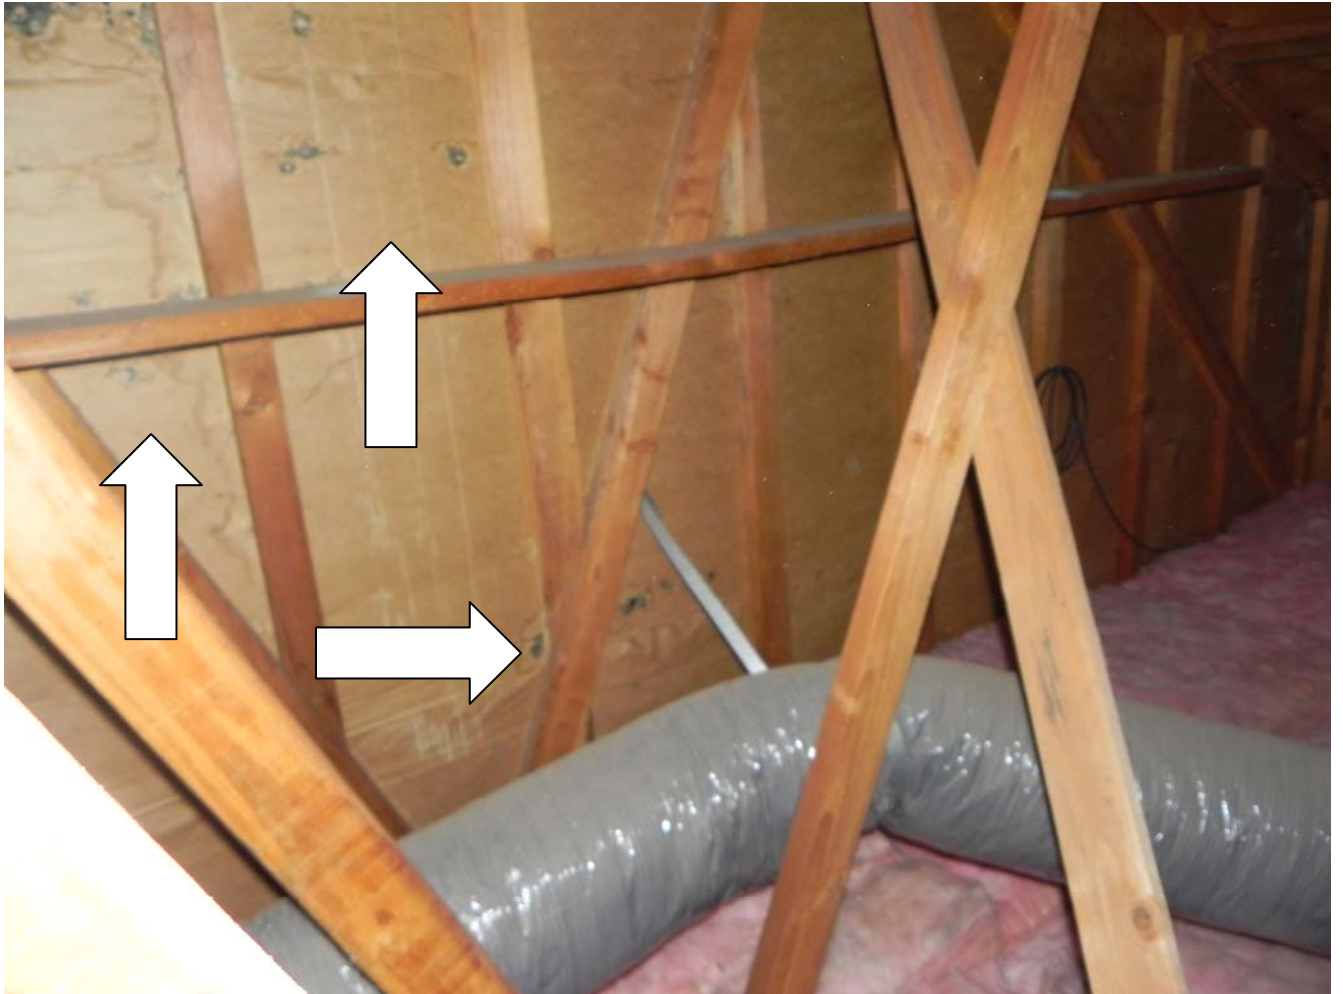
Attic Space – Gable at East End – Moisture Barrier Paper – Visible water and mold damage

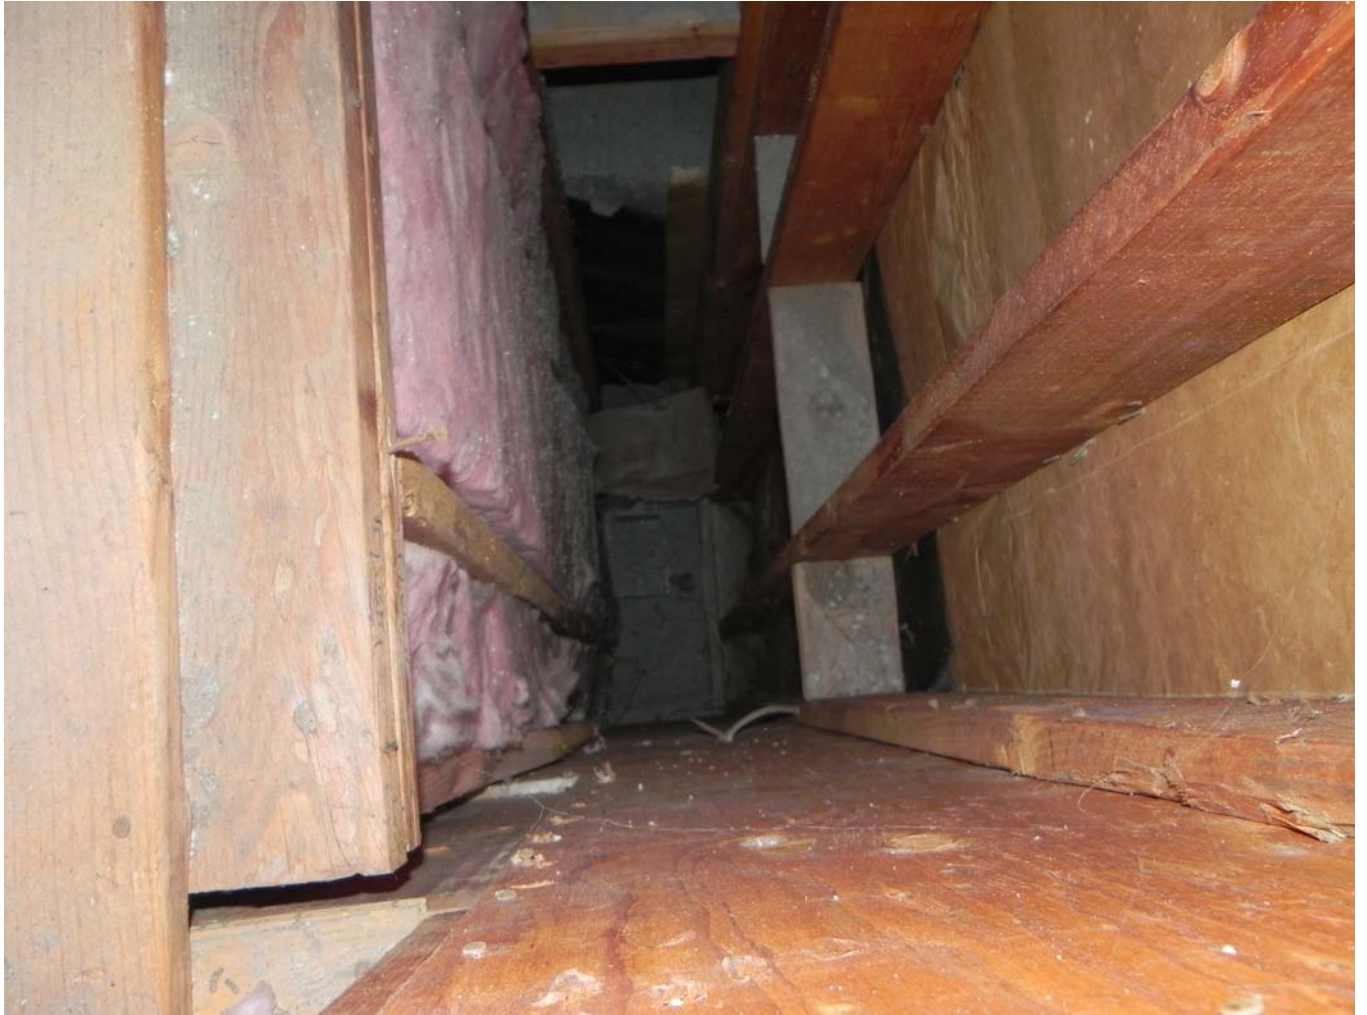
Attic Space – Chase at center of attic adjacent to the pitched roof line

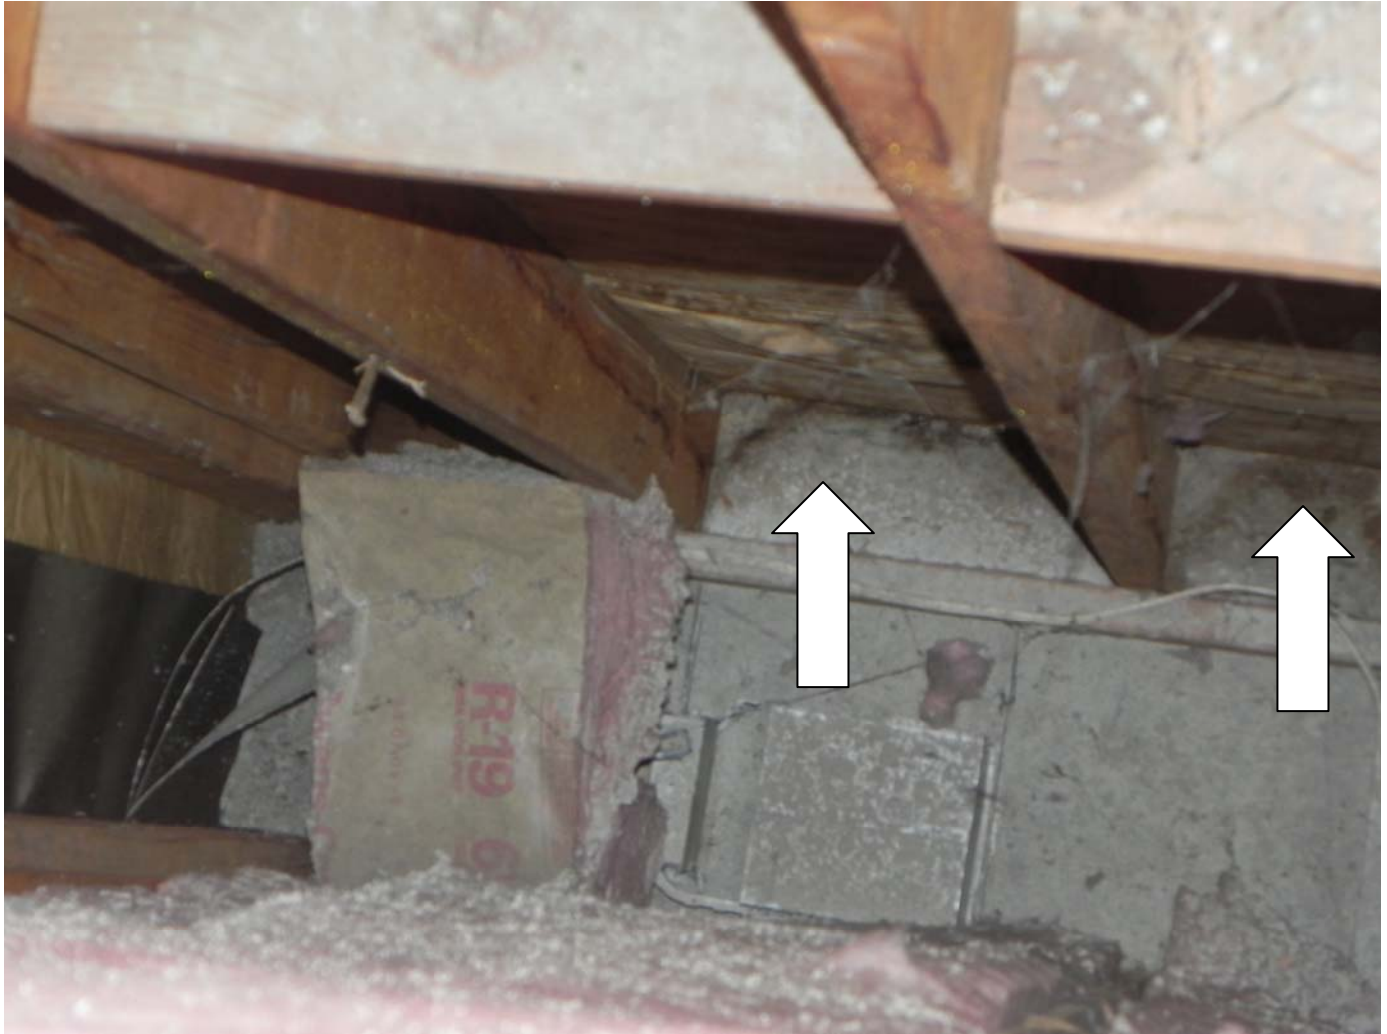
Attic Space – Chase – Center of attic – Bottom of west exterior wall (common to the garage) – Moisture barrier paper – Visible water damage and mold growth

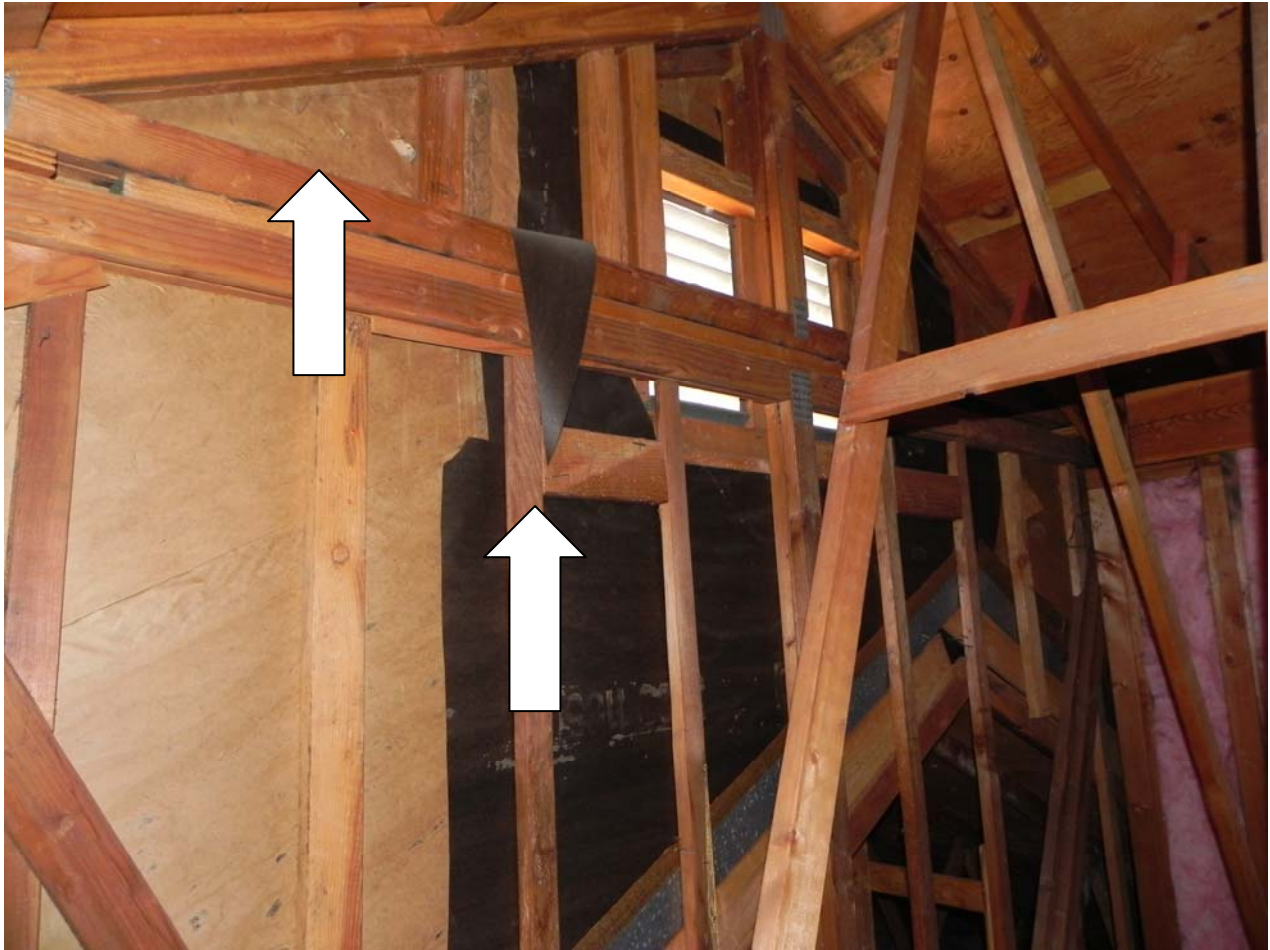
Attic Space – Gable at West End – Moisture Barrier Paper – Visible water damage and mold growth – Note: Different types and installation of moisture barrier paper

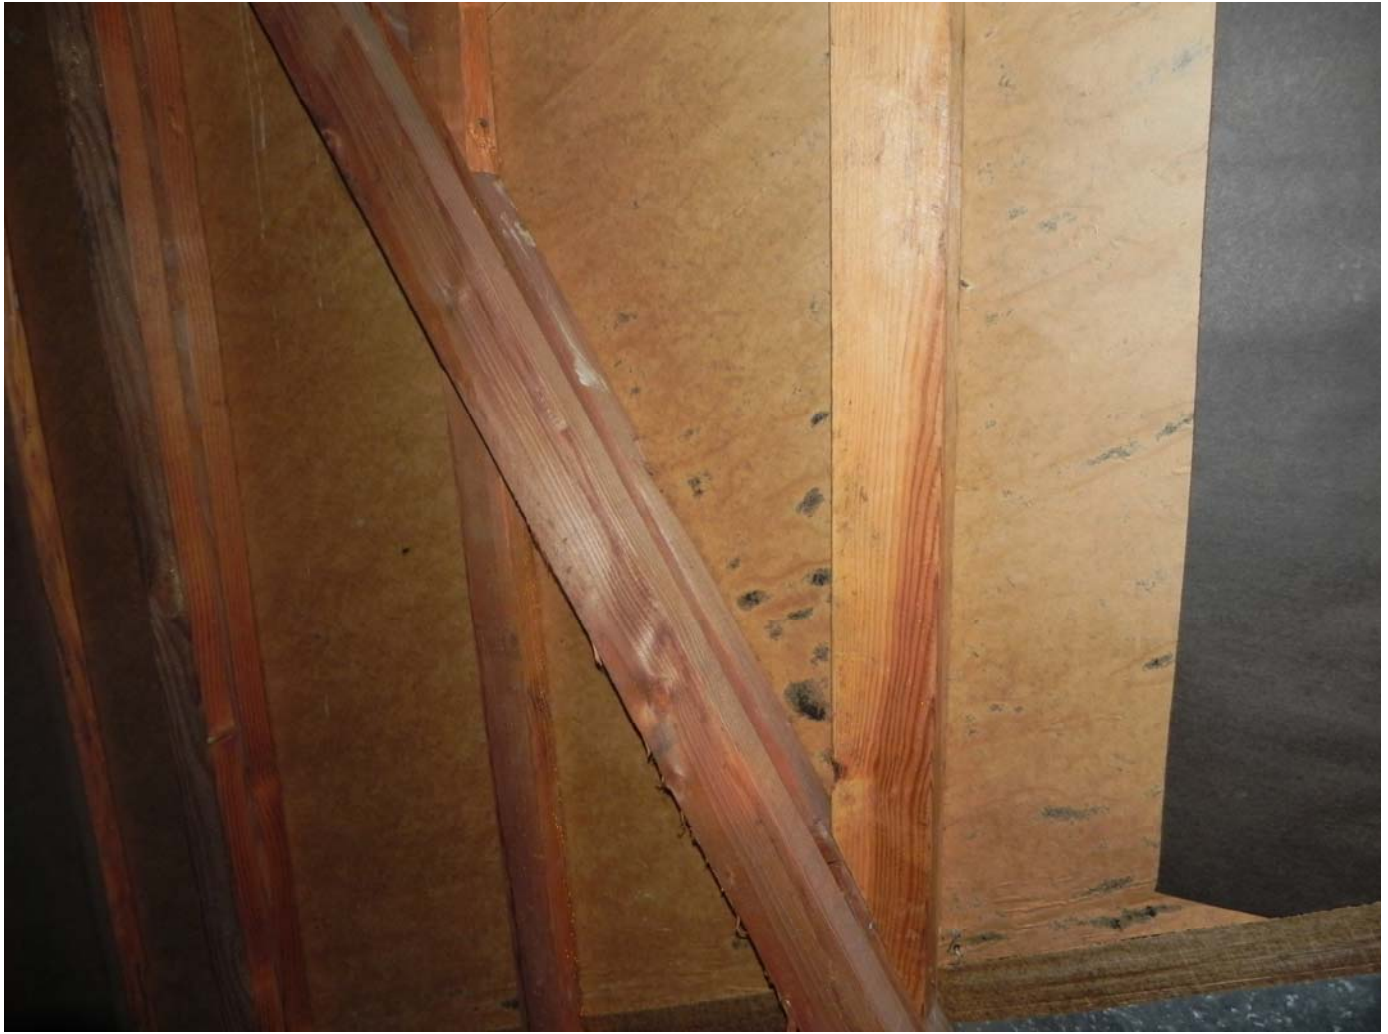
Attic Space – Gable at West End – Moisture Barrier Paper – Visible water damage and mold growth

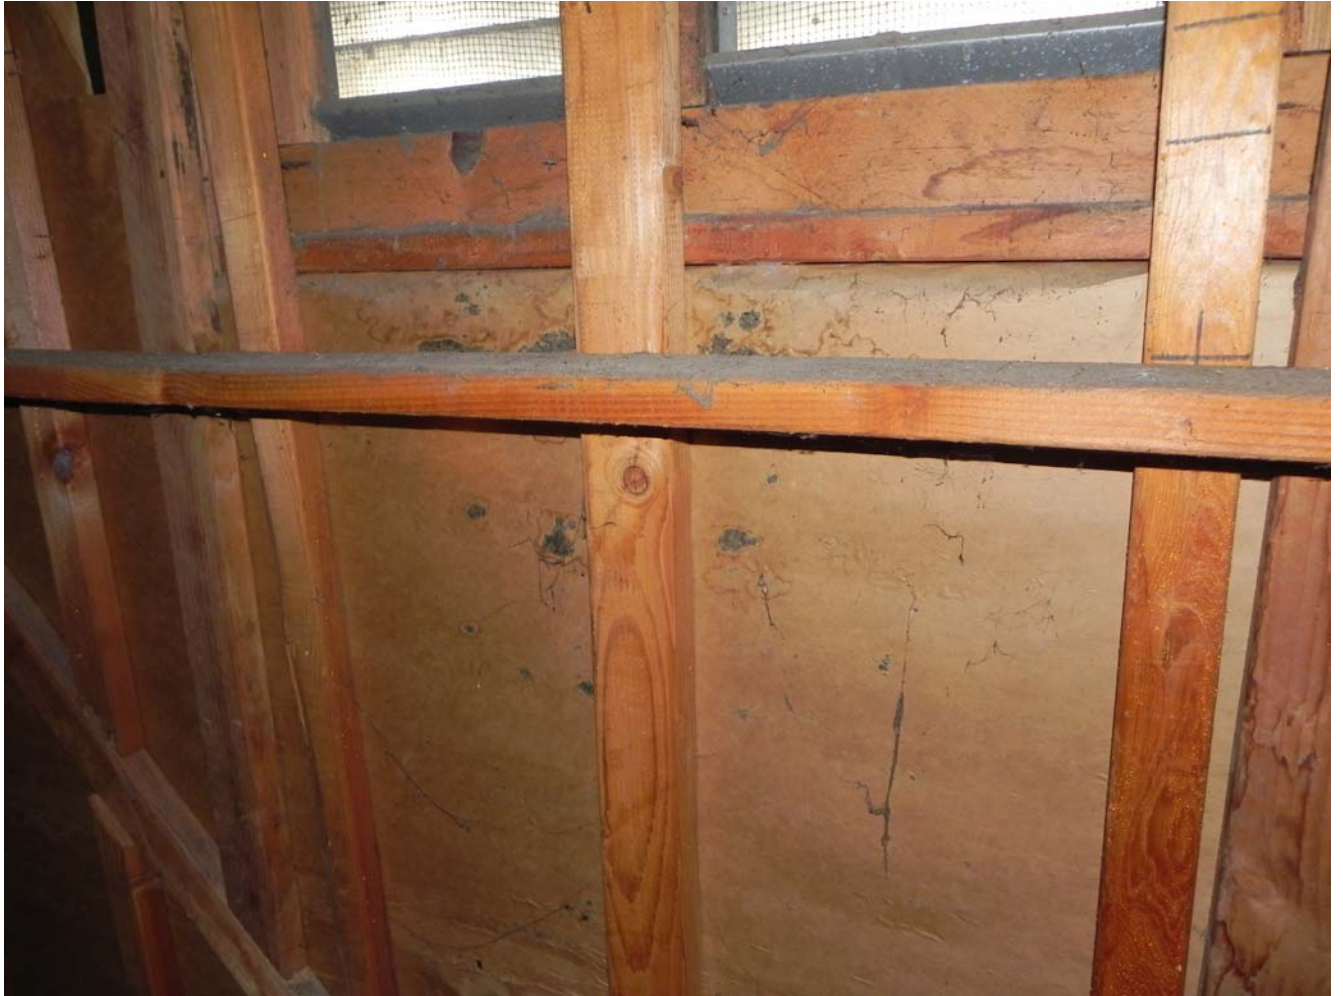
Attic Space – Gable at West End – Moisture Barrier Paper – Visible water damage and mold growth

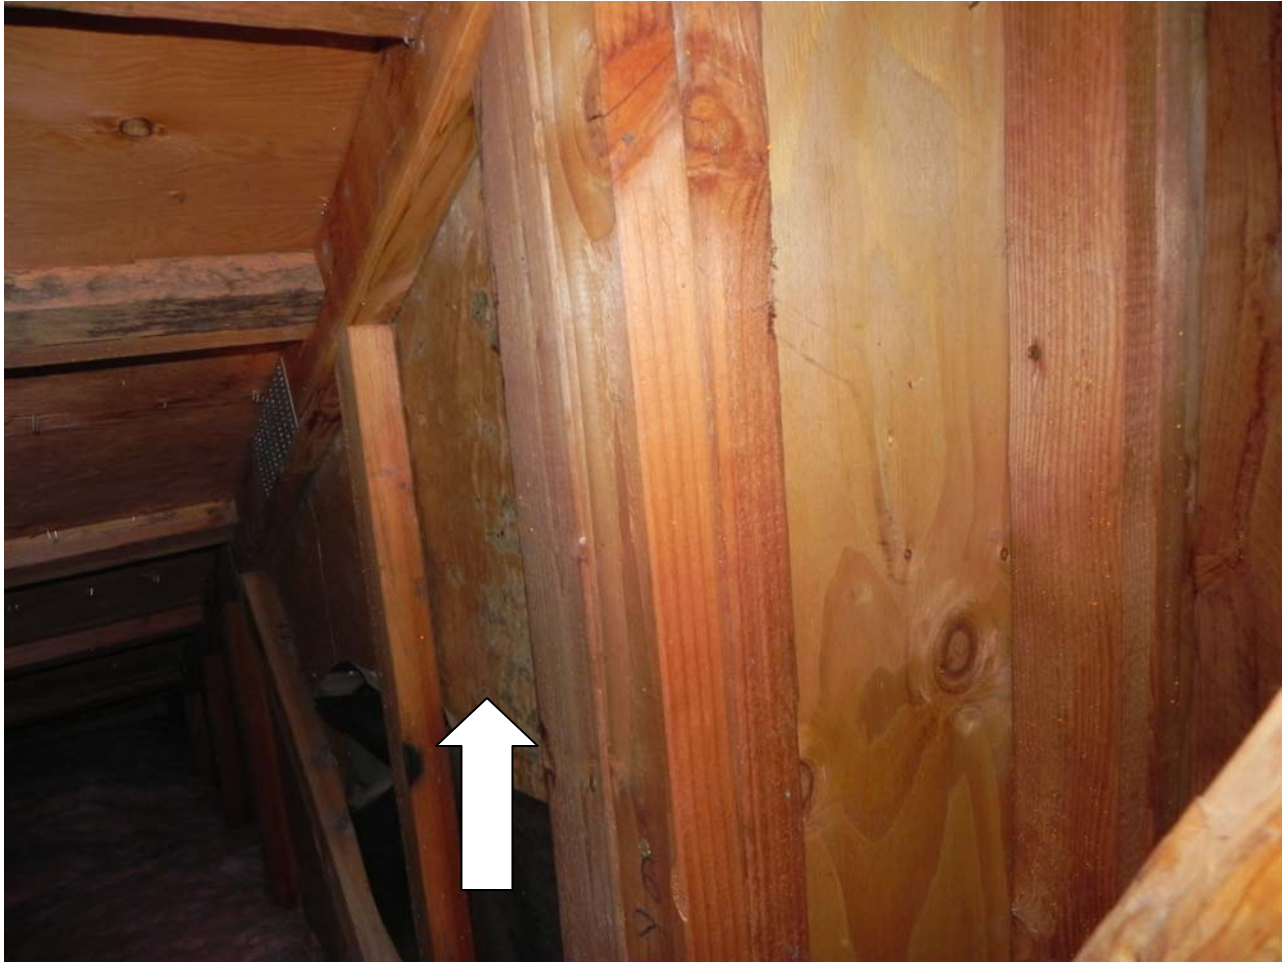
Attic Space – Gable at West End – Moisture Barrier Paper – Visible water damage and mold growth

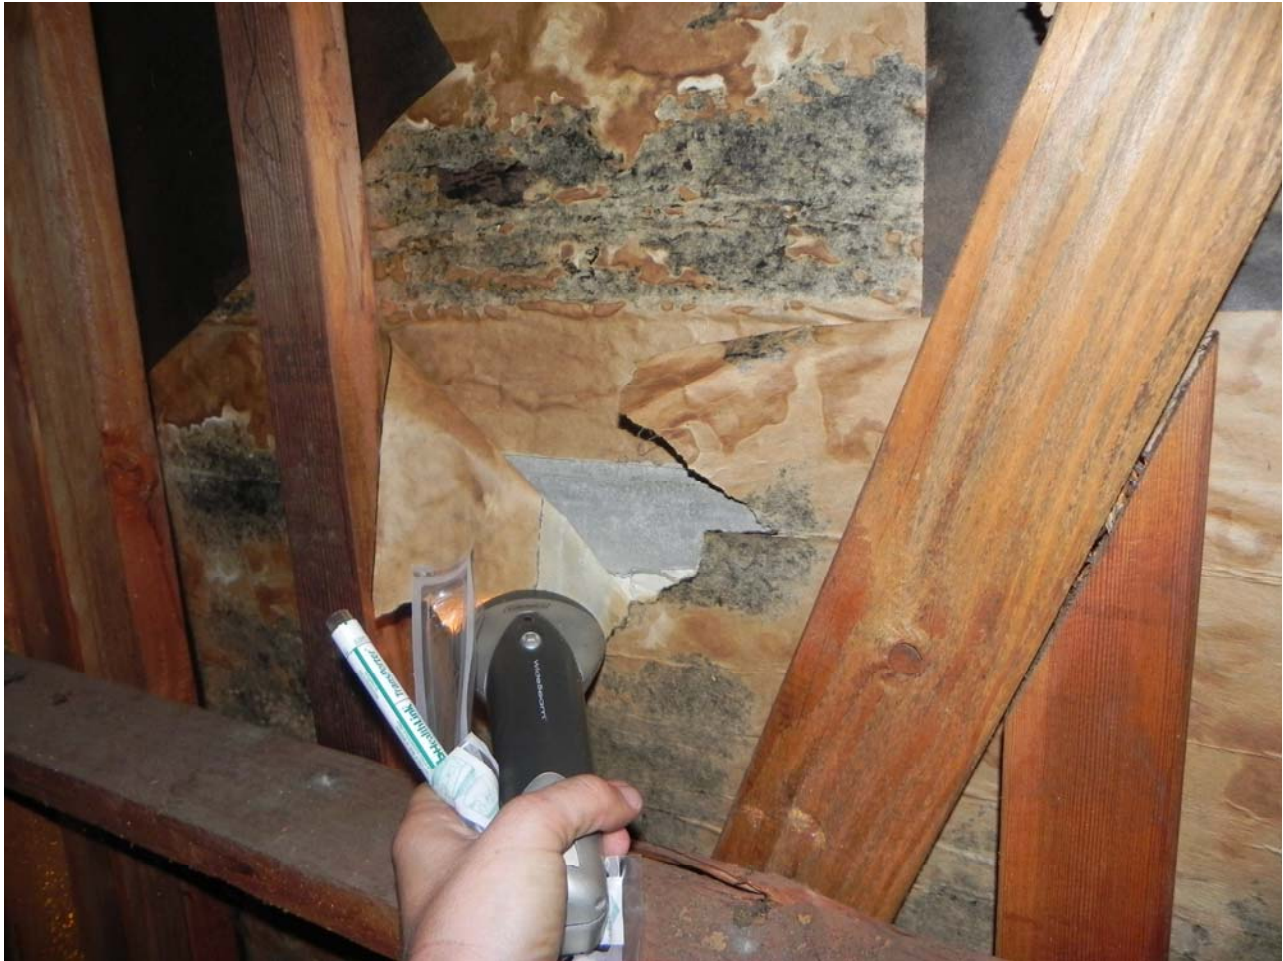
**Attic Space – Gable at West End – Moisture Barrier Paper - No metal lath or substrate –
Stucco applied directly to paper**
